Matafonua Beach Resort Findings

Nov 2015 .

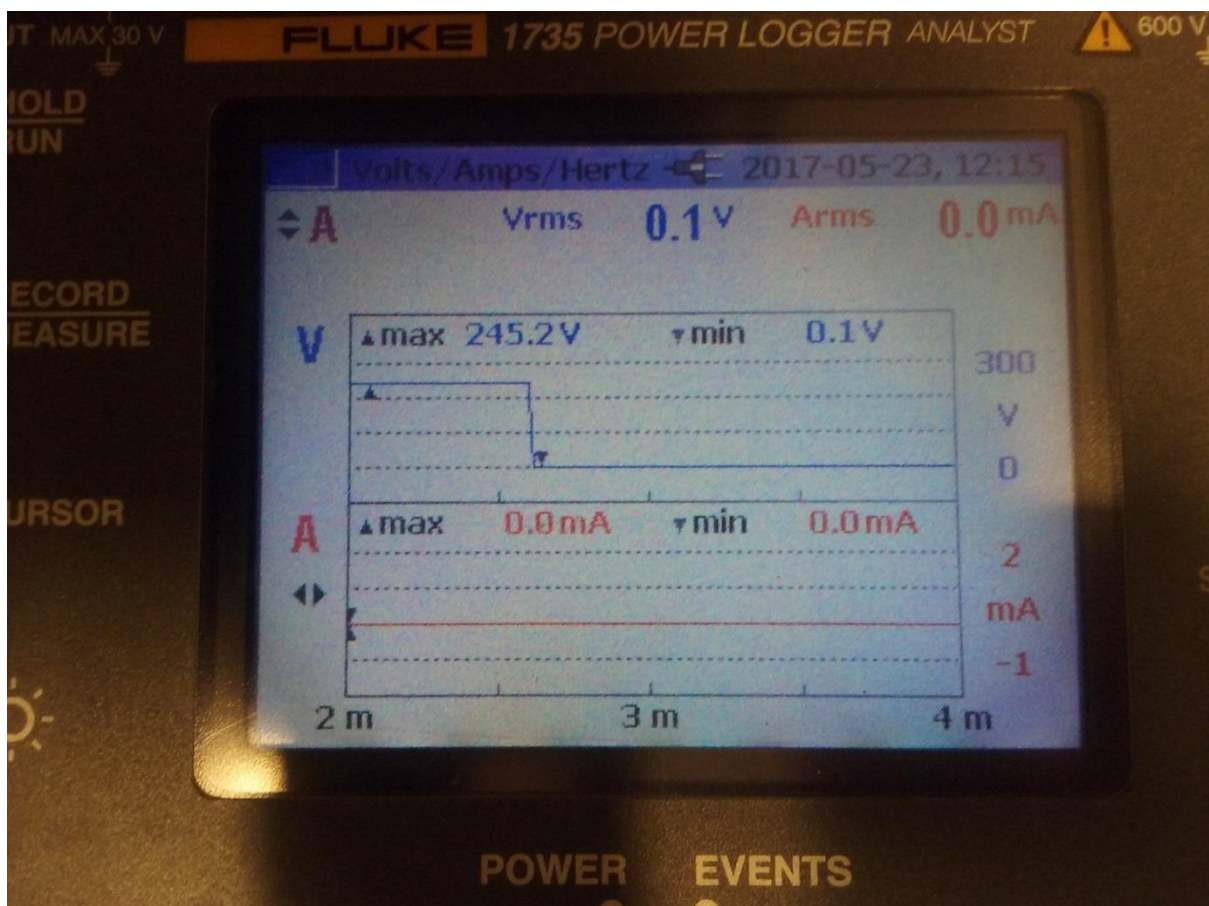
Feeder being turned off.

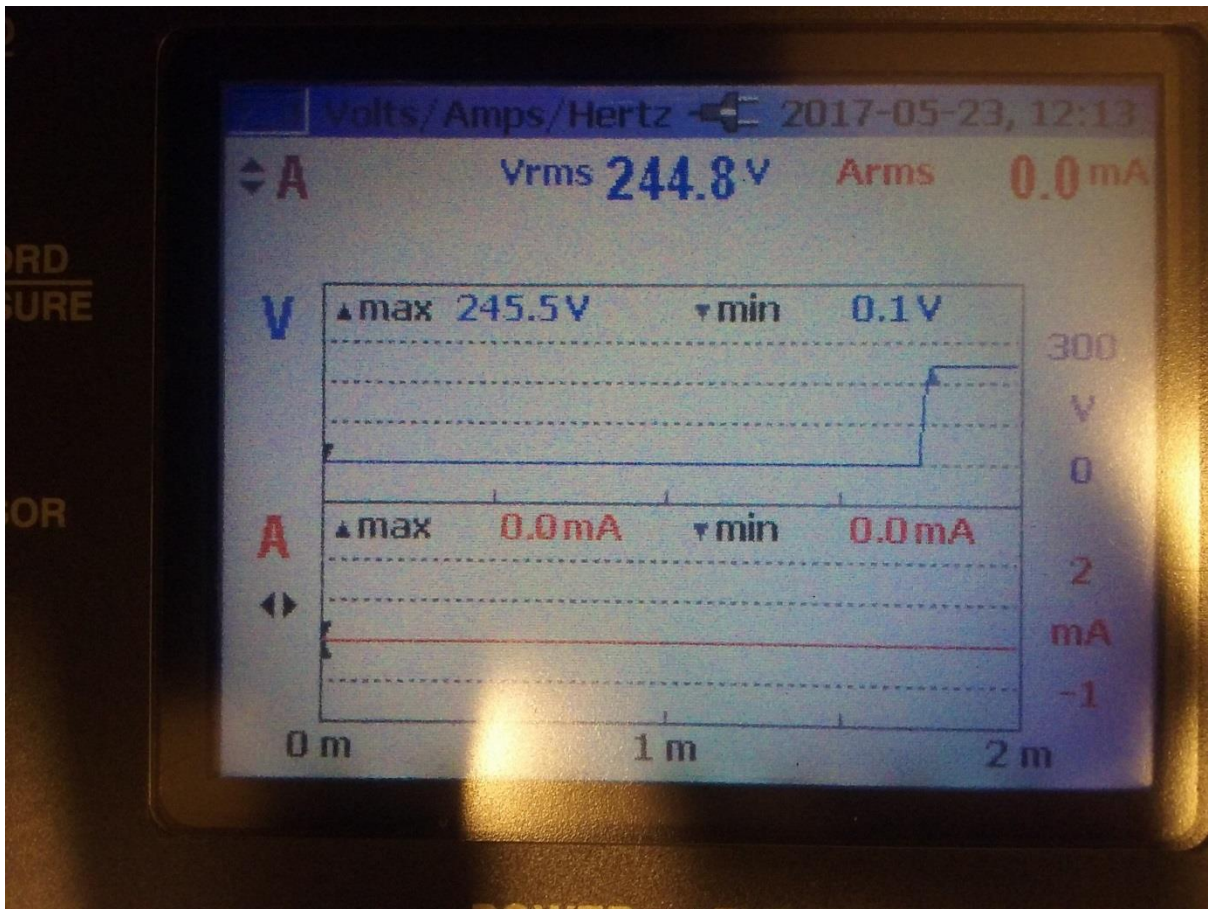
Feeder being turned on.

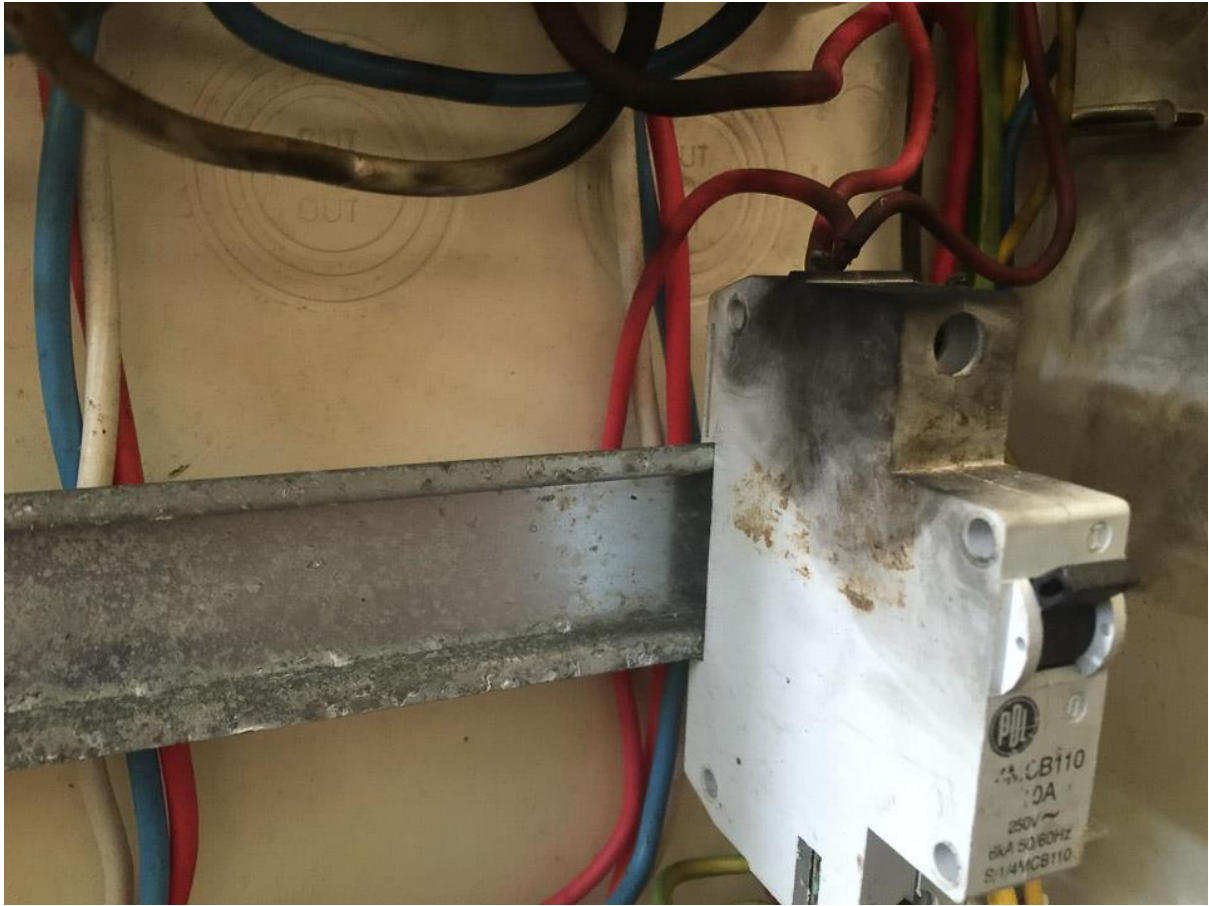
There is evidence of an arc occurring in the main switchboard. This must have been caused by a serious overvoltage event. See photos below.

It apparently happened on the day of change over from 6.6 kV to 11 kV. The transformer feeding the site is a selectable 6.6 / 11 kV type. Maybe when 11 kV was applied, the tap setting was still on 6.6 kV?

A close up of main switch board where one arc must of emerged from.

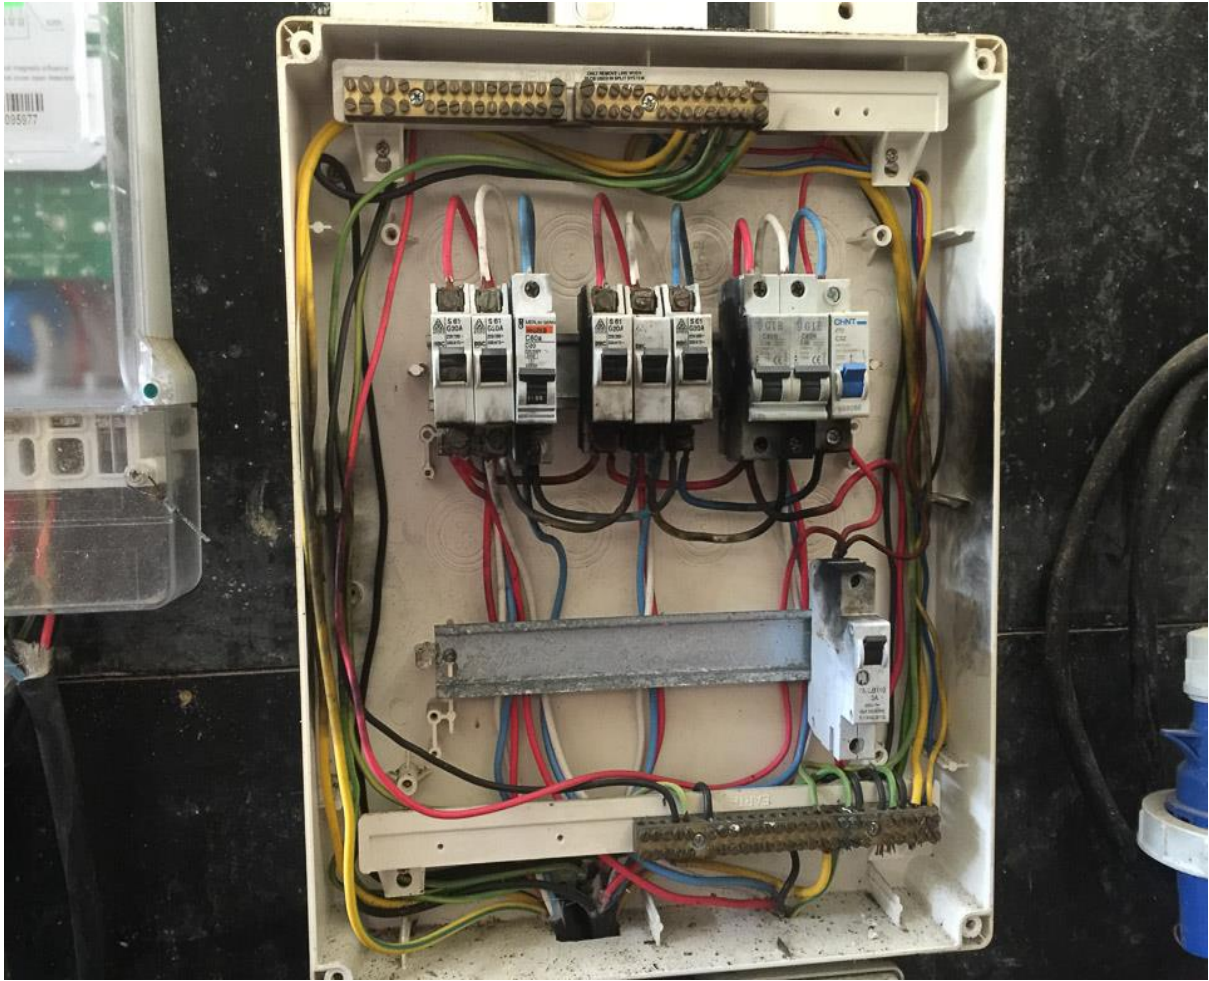
Board was well built.

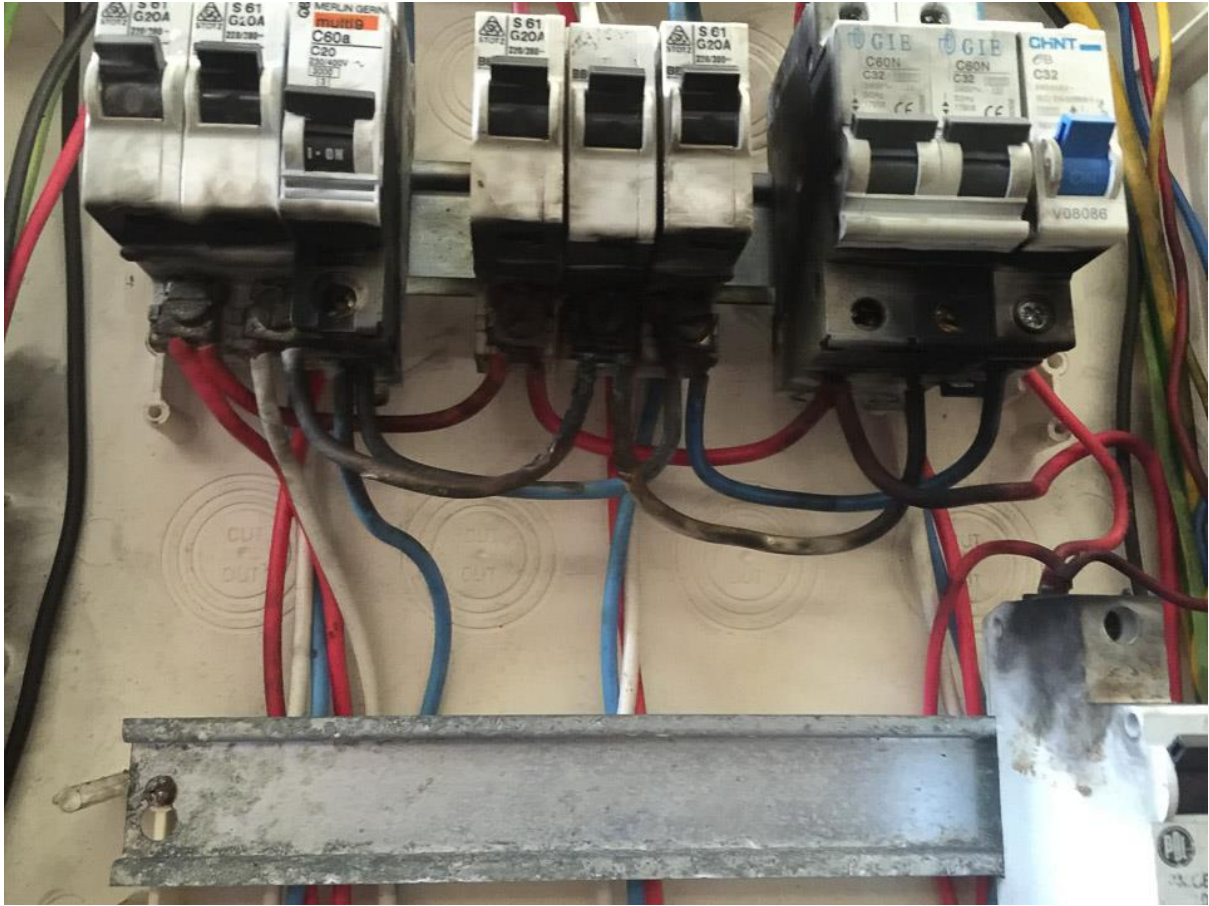
I arrived on site and opened up the main 3 phase switch board. We noted obvious signs of a flashover between phases on the circuit breakers and main switch, which occurred back in November 2015. I was told that this happened on the day of the changeover from 6.6kV to 11 kV was done.

Evidence of flashover in main switch board between phases. Note wiring insulation was not melted showing there were no high currents in wiring.

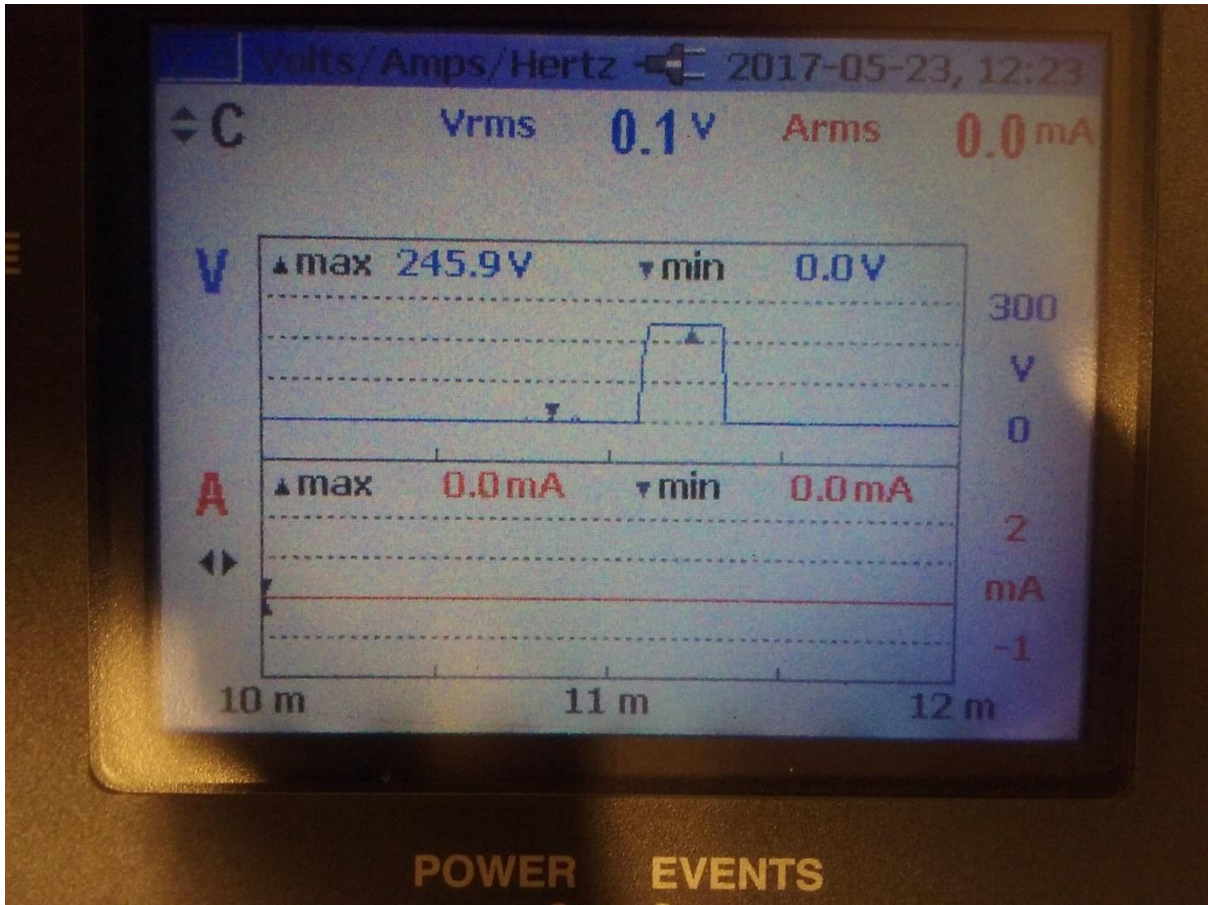
On switching back on, again no ringing or overshoot. Gen sets tripped after 10 seconds due to under excitation then restarted, feeder switched on again, no overshoots or ringing observed during these events.

Feeder being turned on then complete station outage due to trip caused by statcom delay in starting.
